Appendix 37

Asset management reports supporting identified projects

Communication Cables

Asset Management Report YE 2012

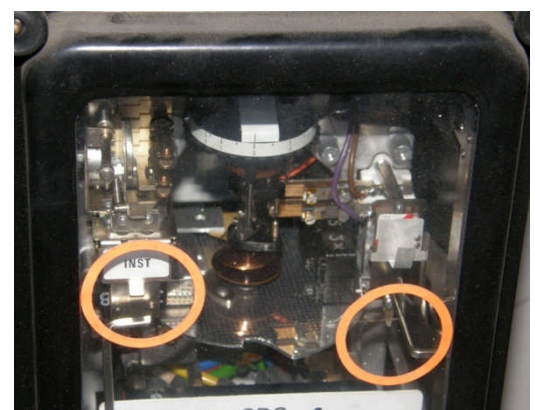
- **Electro-mechanical Relays**

These were widely used throughout the network until the introduction of electronic protective devices in the 1980s. They are very complex in construction and susceptible to vibration. However they are very robust electrically and continue to perform adequately in situations where fault levels and clearance times are not onerous e.g. some areas in the rural network. There have been occasions where electro-mechanical relays have not been suitable due to increased complexity of controlling the network and demand for 'smart' capabilities.

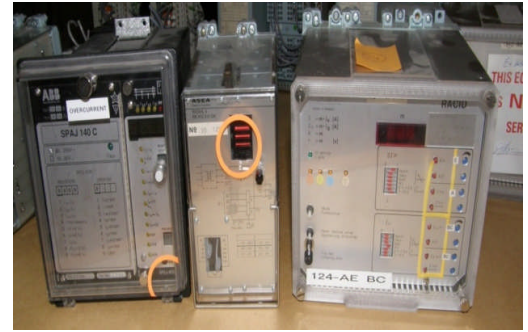
- Analogue Electronic Relays

Also known as 1st generation IEDs these relays are less susceptible to vibration and require less maintenance than their electromechanical counterparts. While they have slightly improved functionality and a smaller physical footprint, they are not capable of remote diagnostics via SCADA. Each of the individual protection elements are made up from discrete relay units.

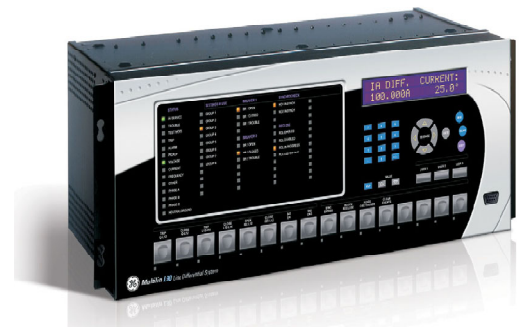
- Digital Electronic Relays

These 2nd generation IEDs use microprocessor technology and are superior to their predecessors in many ways. Being microprocessor based means they are capable of performing multiple protection functions and provide a platform for remote diagnostics/control via SCADA. Storage of pre and post fault data for events has proven to be very useful in determining the cause of system faults.

While electronic relays have additional benefits, some consequences need to be considered, such as shorter lifecycles, software and firmware upgrades and increased standing load requirements on the substation battery bank.

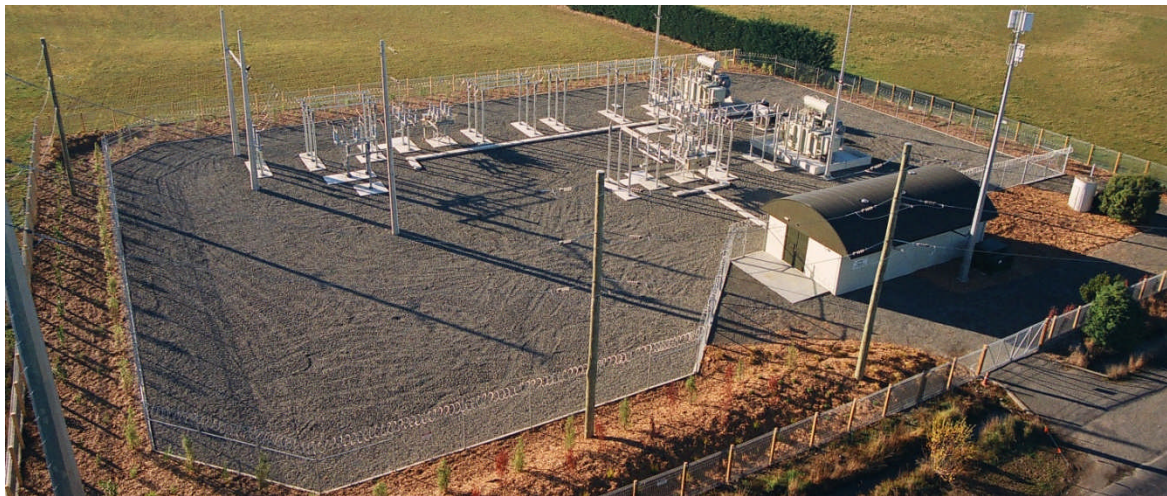
Figure 3: Weedons 66/11kV Zone Substation

The six rural 66/11kV zone substations at Killinchy, Te Pirita, Greendale, Brookside, Dunsandel and Weedons are supplied by overhead lines and have 7.5/10 or 11.5/23MVA transformers. All have outdoor structures. The indoor 11kV switchgear may supply up to five feeder cables.

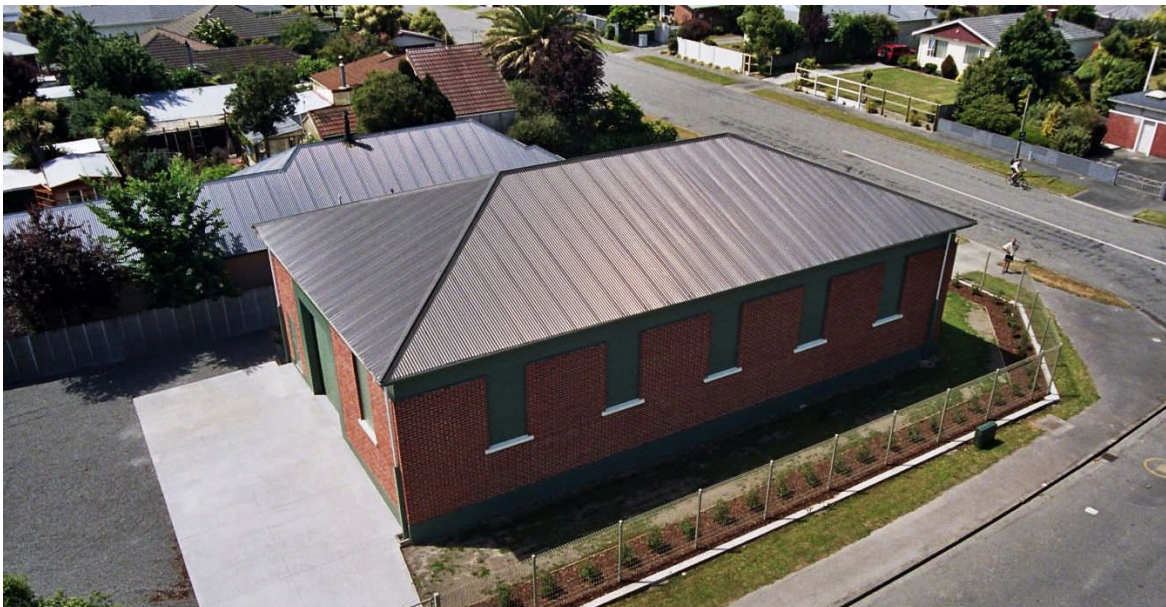
Figure 5: Grimseys Winters 11kV Zone Substation

We have 10 of these substations, all in the Christchurch city urban area. They are directly supplied by either three or four radial 11kV cables and do not have supply transformers. The cables have usually been laid along the same route and have sufficient capacity to supply the full zone substation load. The 11kV switchgear may supply up to 12 feeder cables and is housed in either two or three switch-rooms linked by bus-couplers.

None of the 11kV zone substations have any form of outdoor structure or bus-work.

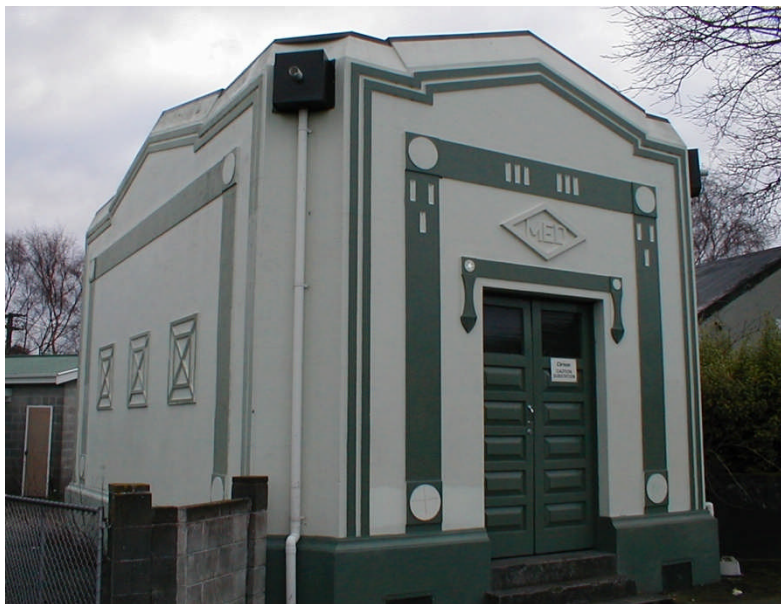
Figure 6: Network Substation (Built in 1930s)

There are 248 network substations in our primary 11kV network, all are within the Christchurch urban area. They contain at least one 11kV circuit breaker per connected primary cable and one or more circuit breakers for radial distribution feeders. They may also contain secondary 11kV switchgear, one or more distribution transformers and an 800A or 1500A 400V panel with fuse assemblies using high rupturing current (HRC) links for local distribution.

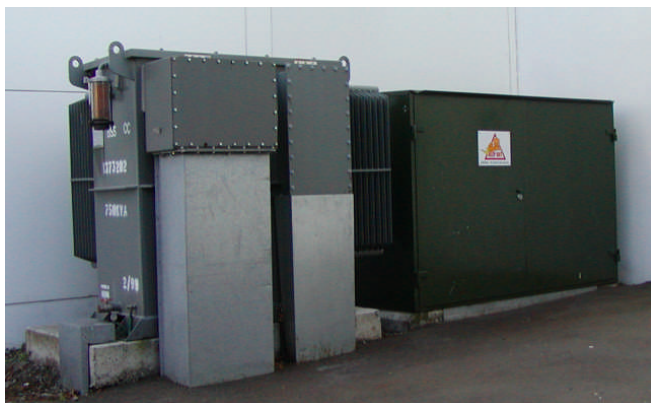
Figure 8: Typical Outdoor Distribution Substation

Pole	6,242	Mainly single pole substations, usually with 11kV fusing and a transformer up to 200kVA. Some are a 2 pole structure (approximately 20) and may have a transformer of up to 300kVA installed.
Pad transformer	628	These are transformer only, mounted on a concrete pad and supplied by high voltage cable from switchgear/fuse at another site. Transformers are uncovered except for approximately 33 that are enclosed in a polythene or fibreglass cover.

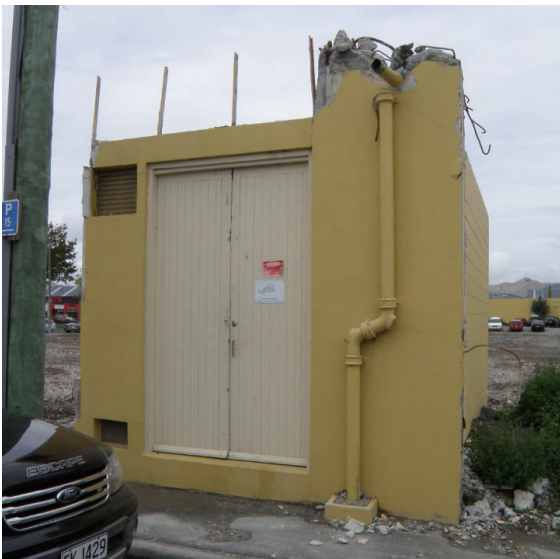
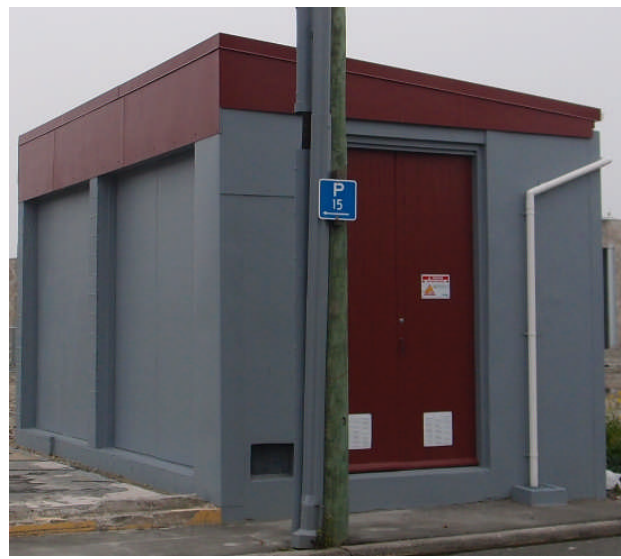
Figures 6-7: Alfred Street Substation – Before and After Surrounding Demolitions

At the time of writing significant changes have been taking place in the CBD. As a result some of the privately owned buildings have been demolished leaving behind the substation only. Where appropriate we have reroofed and reclad these buildings to make sure they are weather proofed. The final make up of how many network buildings will remain in the CBD is unclear at this stage.

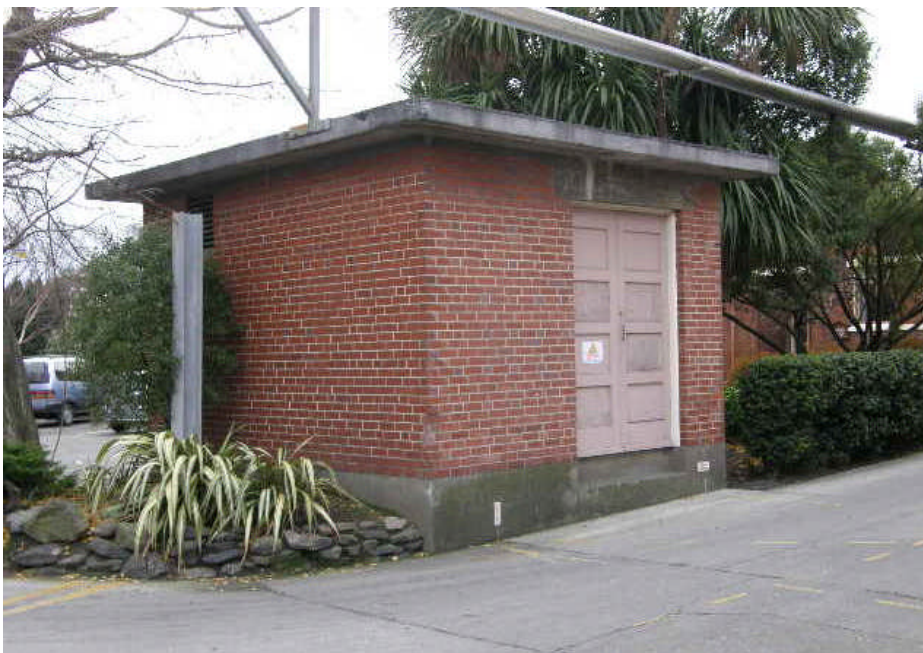
Figure 9: Example of a Privately Owned Distribution Substation – Davis Gelatine

Similar to the network substation buildings Orion owns 80 of the distribution substation buildings currently being utilised on the network. There are 187 privately owned substations and they are generally part of another building within a customer's site.

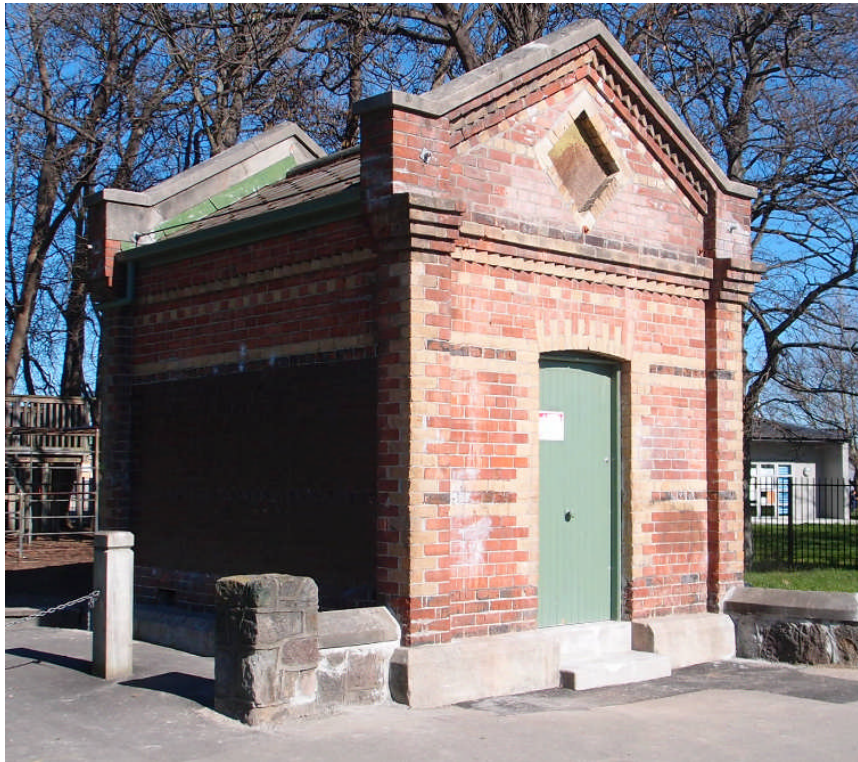
Figure 10: Example of an Orion Owned Heritage Distribution Substation – Ferry Rd Woolston Park

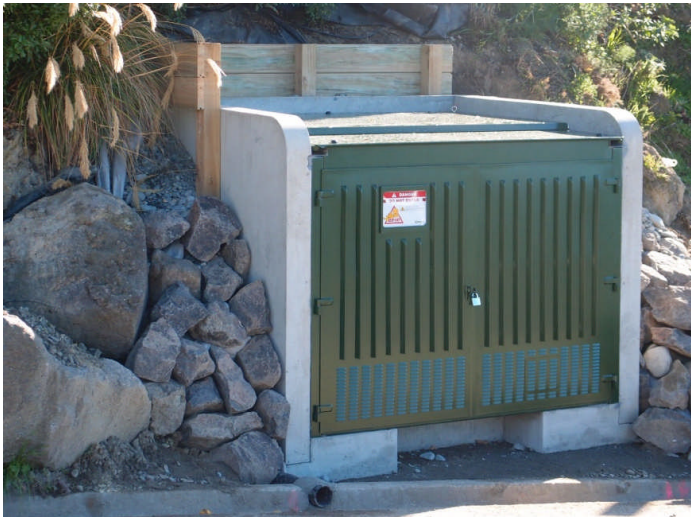
Figure 13: Example of a Concrete/Steel Kiosk

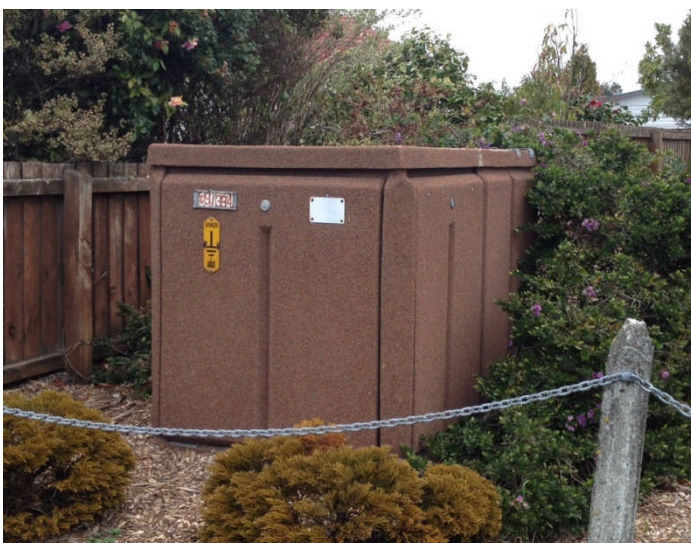
Figure 14: Example of a Fibreglass Kiosk

We currently have 3,528 kiosks and transformer covers on our network housing equipment for the distribution of electricity. The kiosks are largely in good condition and fared reasonably well during the Canterbury earthquakes. The large majority of the kiosks are powder-coated steel and we also have 25 fibreglass/stone-chip kiosks. We are looking to initiate a plan to replace the fibreglass kiosks.

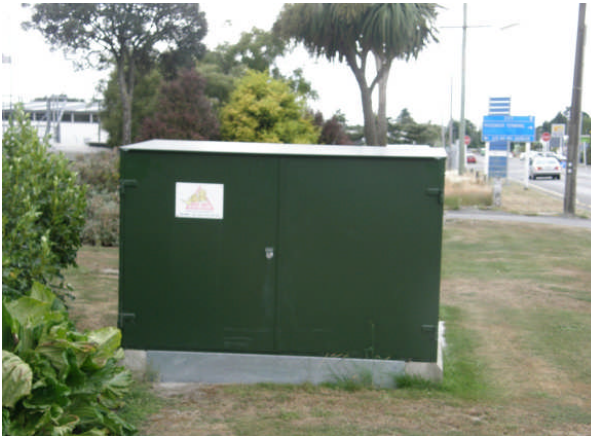
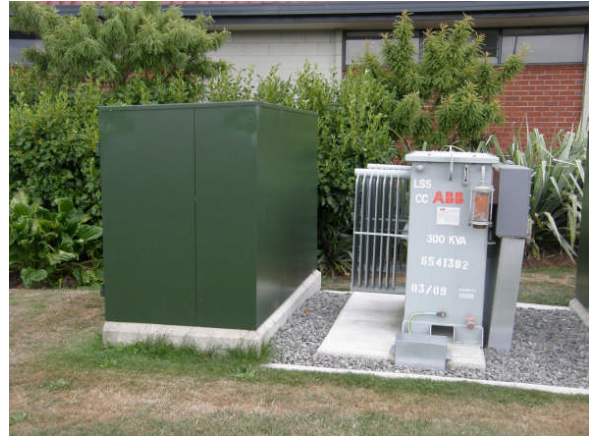
Figure 15: Example of a Half Kiosk

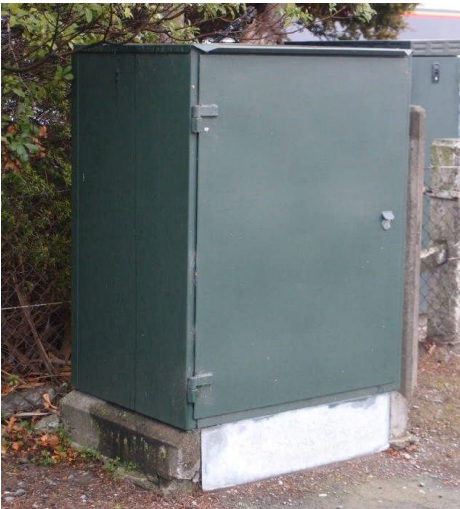
Figure 16: Example of a Quarter Kiosk

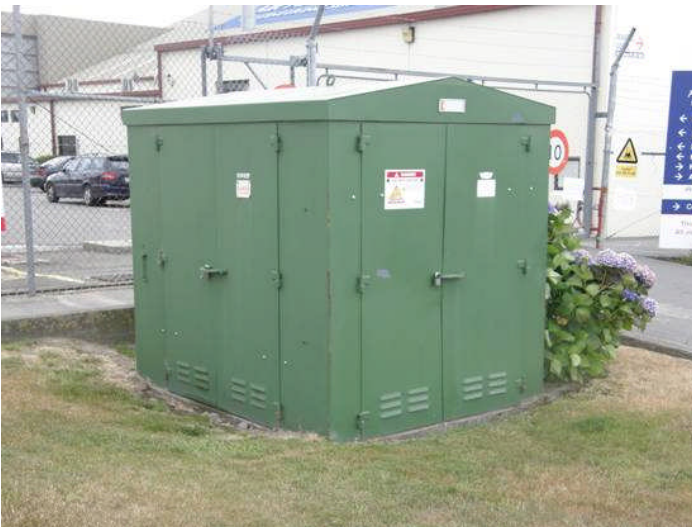
Figure 17: Example of a High Kiosk

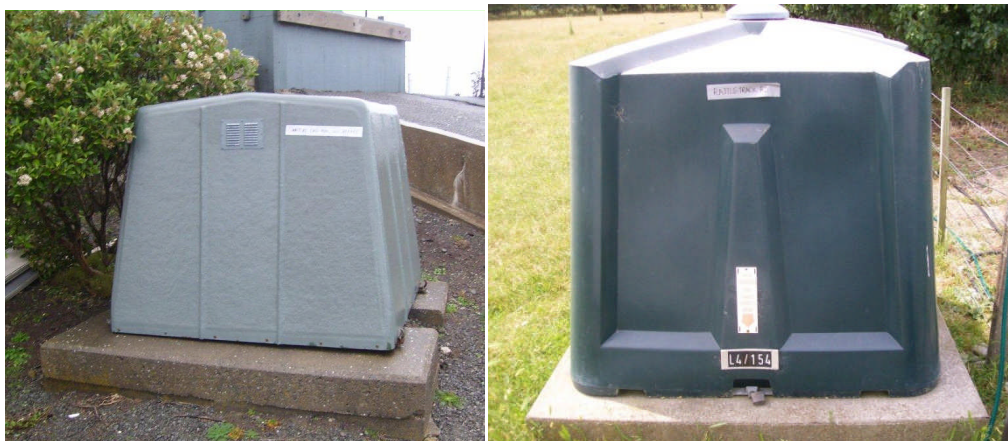
Figure 18: Example of Fibreglass and Polythene Transformer Covers

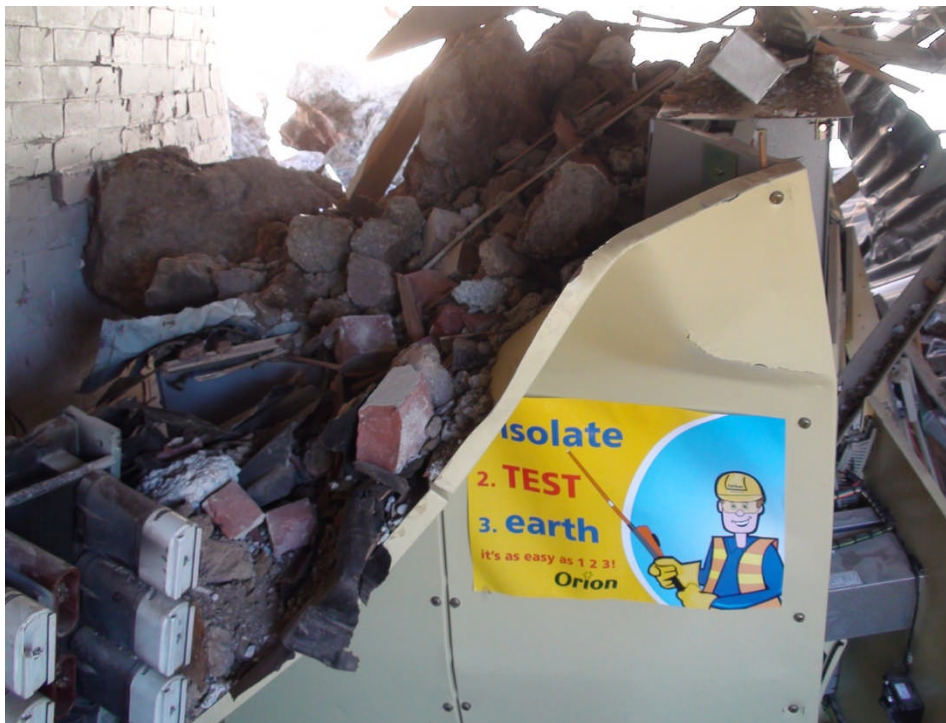
Figure 19: Wakefield Avenue North Substation

Across our network we observed only minimal damage to our distribution substation buildings and kiosks. The worst seismic damage occurred in the Sumner/Redcliffs area due to rock falls and landslides in the February 2011 earthquake. There was minimal extra damage after the June earthquake.

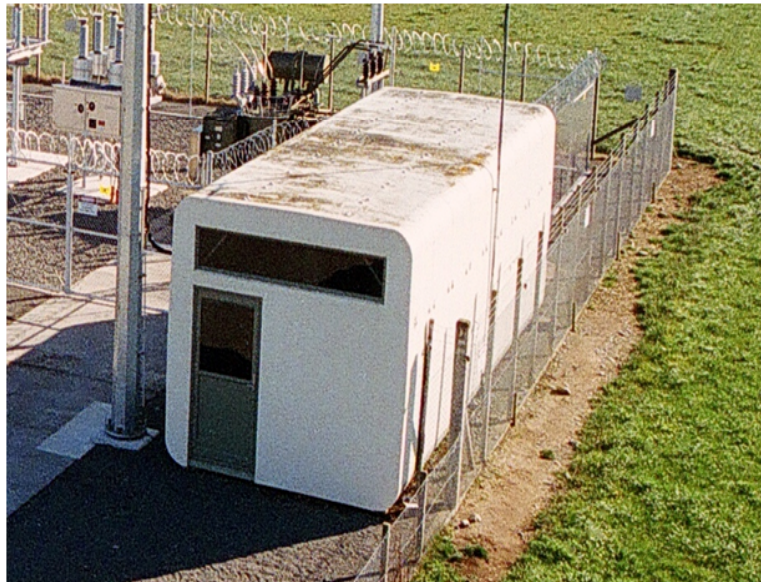
APPENDIX A - CONDITION ASSESMENT SHEET

Site	Annat	Building Condition Assesment - Annat - KO12/67						
Construction Type	Modular	Building Sections		Specific Factors	Weighting	Score (/10)	Total	Comments
Site Number	KO12/67	Roof	25	Roof	15	8	12	Cleaning required
Sub Designation	Zone Sub			Gutters	10	NA	10	
Sub Rating (MVA)	2.5	Security	30	Surrounding Fencing	10	10	10	
Primary Volt (kV)	33			Doors	10	10	10	
Current FY	2013			Locks	10	10	10	
Construction Date	1981	Safety	20	Trench Plates	5	NA	5	
Roof Reclad	NA			Barriers (if required)	10	NA	10	
Seismic Upgrade	2000			General	5	10	5	
Age (yrs)	32	Construction	25	Strengthening	5	10	5	
No. Customers (approx)	516			General Condition	20	8	16	Modular construction has leaked in the past
						Total Score	93

In an effort to better record the condition of our zone substation buildings, we are developing an asset ranking system. This system was used for other assets prior to CBRM being introduced. We have developed 'condition assessment' sheets for each building (including transformer enclosures). Over time we will populate these sheets and use them as the basis for our ongoing maintenance and renewal plans. Once this process has been fully implemented and working, we will undertake a review to determine if there are any benefits to creating a CBRM model for these assets. Refer to Appendix A for an example of a condition assessment sheet.

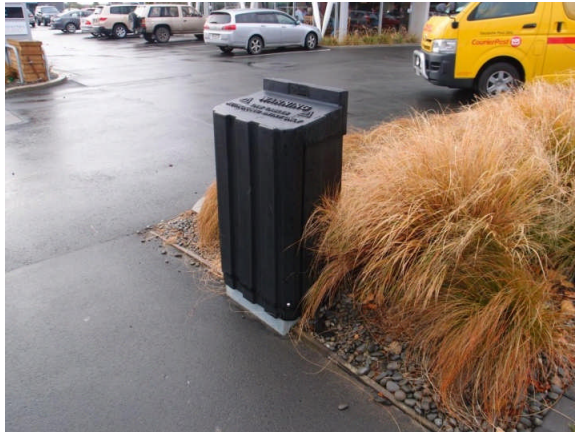
Figure 4b: Distribution Cabinet – Current Design

These Distribution Cabinets were formerly known as Link Boxes.

We have 5,600 distribution cabinets installed on our LV cable network. Sufficient cabinets are needed to allow the system to be reconfigured (that is, each radial feeder must be capable of supplying or being supplied from the feeder adjacent to it) in the event of component failure or other requirements. All of our distribution cabinets are installed above ground. Older ones are generally steel and the later ones are a PVC cover on a steel frame.

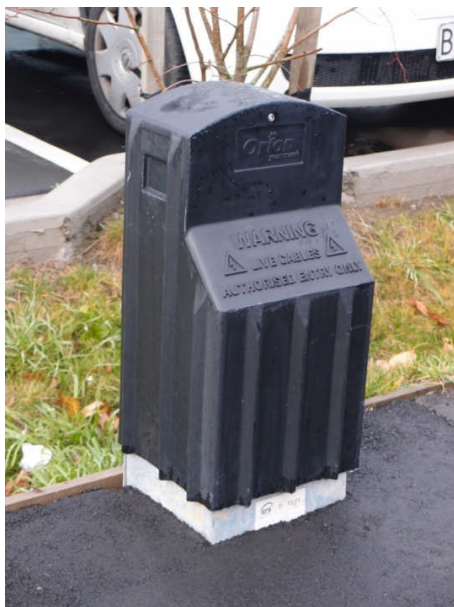
Figure 5b: Distribution Box – Current Design

These Distribution boxes were formerly known as Boundary Boxes.

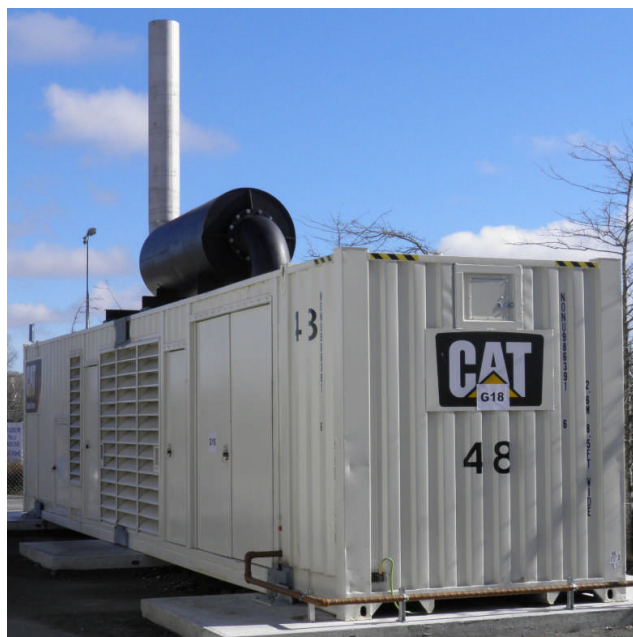
Figure 2: 11kV Generator Details

Generator Details	
Model	XQ2500
Make	Cat
Location	QE11
Quantity	2
Voltage	11000
KW	2000
kVA	2500
Sync	Yes
Comms	Ethernet
Weight	36,000
Tank	4400
Revenue Meter	Yes

Presently these generators are located at QEII. In 2016 they will most likely be moved to Belfast. The generators primary purpose is to boost the 11kV network under N-2 conditions. They are also used for peak lopping. They can also be islanded.

The generators have engine control units with electronic injectors but are not classed as common-rail. The fuel rail is low pressure with the pressure rising in the injector. The generators have digital AVR's (CDVR) and Woodward EasYgen 3200 P1 digital touch screen controllers. These have a Proconx Ethernet interfaced through CAN1.

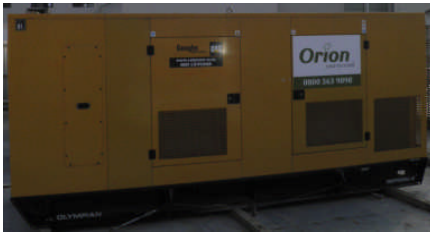
All the 550kVA generators are low emission and have an electronic common rail fuel system.

2.3.1 G02, G03, G04, G05 - Cat GEP550-2 - 400V Emergency Standby

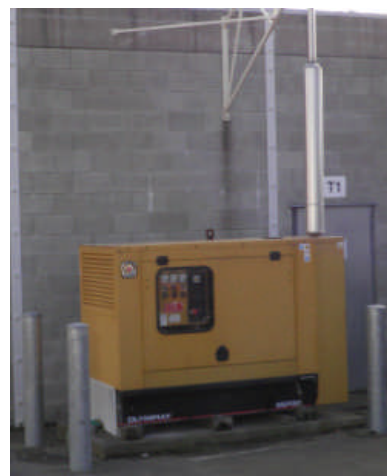
Figure 7: Armagh Zone Substation Standby Generator Details

This generator is located at 200 Armagh St and provides an auto mains failure changeover supply for our Hot-site. In turn the Hot-site UPS provides a supply for the Hot-site servers, one computer in the control room and one computer in the call centre.

Generator Details	
Model	GEP
Location	ARM SUB
Quantity	1
Voltage	400
KW	27
kVA	30
Sync	No
Comms	No
Weight	800
Tank	145
Revenue Meter	No
75%	25 hrs

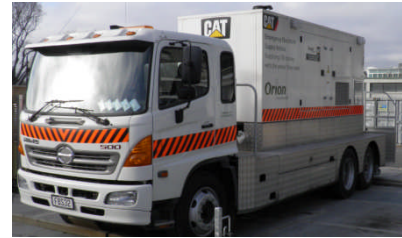
V760

The trucks can each be synchronised to the network and are fitted with revenue meters.

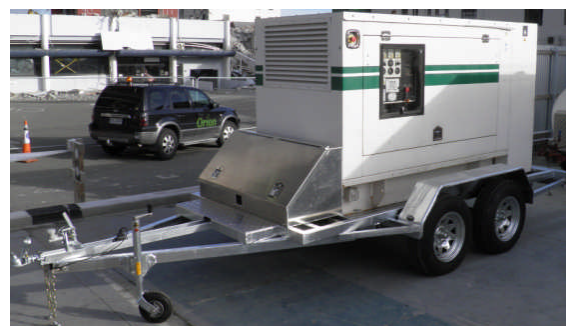
Figure 11: Trailer Generator G21 Details

Generator Details	
Model	P110E
Location	ARM
Quantity	1
Voltage	400
KW	88
kVA	110
Sync	No
Comms	No
Weight	2000
Tank	490
Revenue Meter	No

The 110kVA was the Armagh St Building generator. It has been trailer mounted to allow it to be used for smaller jobs that would otherwise tie up a truck for extended periods. In the future this may be installed with synchronisation gear to allow it to be used for voltage support jobs.

The generator has a basic FG Wilson control panel. The setup allows the generator to be:
